The End of Percussion Maintenance

Mark Jermeay, Ingersoll Rand Fluid Technologies

A new motor technology for diaphragm pumps combats three confounding pump motor issues: freezing, stalling, and poor energy efficiency.

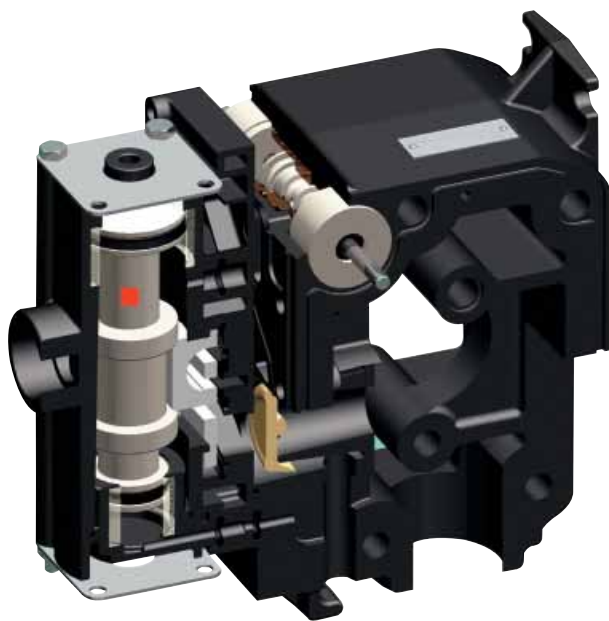
The red dot is placed on the unbalanced major air valve. An unbalanced valve design eliminates valve centering and pump stall-out-even under low air inlet pressures.

Diaphragm pumps can eliminate air valve centering by utilizing an “unbalanced” valve design. This air valve design features a large diameter on one end of the valve and a small diameter on the opposite end, creating the optimal pressure differential. Since the valves are always biased toward one side, they do not center out and stall the pump, even under low air inlet pressures. Unbalanced valves reduce production loss and downtime by providing better shift signals and delivering faster trip-over with more flow.

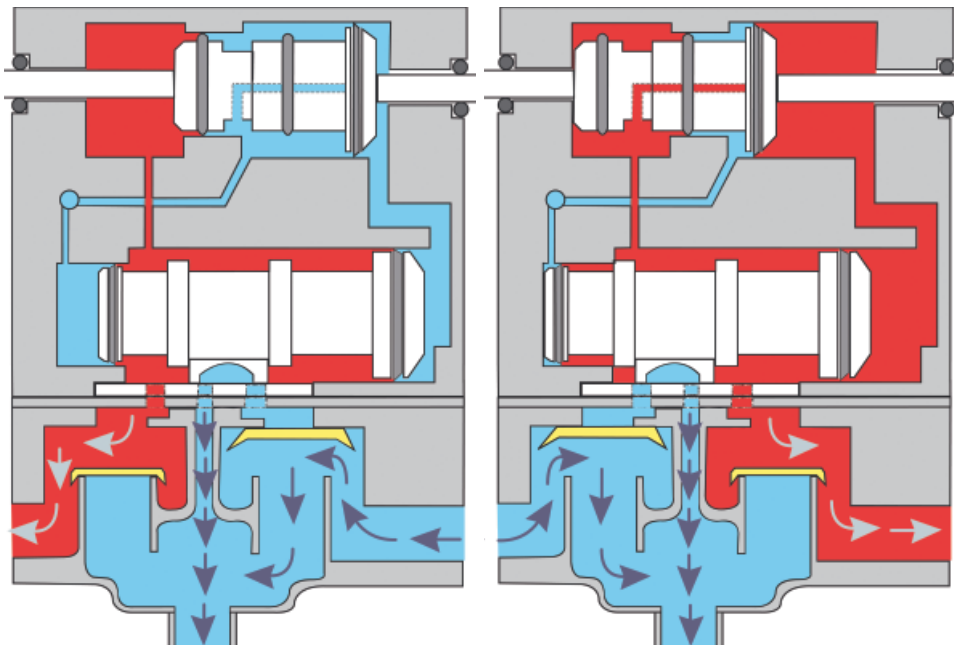
These diagrams show the cold (blue) and warm (red) air movements as the diaphragm moves back and forth. Note how the cold, wet intake air is always diverted from the air valves.

Instead, the most effective motor designs on the market today eliminate pump ice-up by protecting the major air valve from cold, wet exhaust air. Internal components that divert the exhaust air away from the major air valve and into an expansion chamber can dramatically increase pump reliability and remove the need for ice preventive devices.
